PRESERVATION PLAN

INDIANA UNIVERSITY OF PENNSYLVANIA

Indiana University of Pennsylvania
Indiana, Pennsylvania

Prepared by
**PH PITTSBURGH HISTORY &
LF LANDMARKS FOUNDATION**

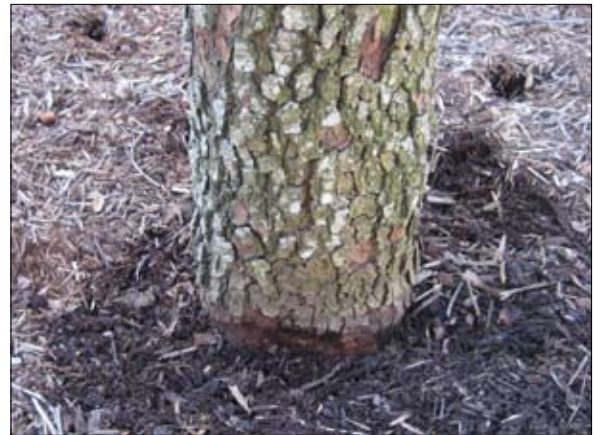
Buried root flare results in a “telephone pole” trunk.

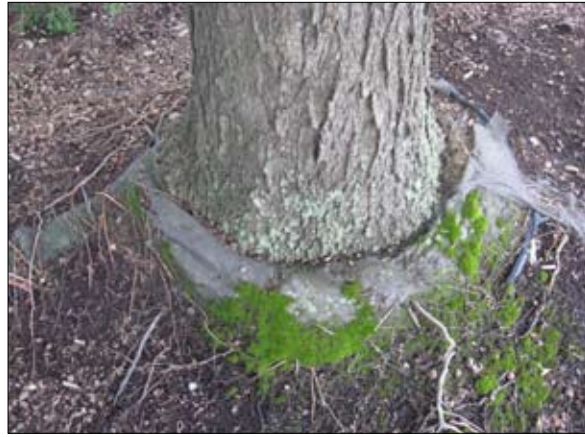
Landscape fabric doesn't decay and interferes with beneficial insects and worms and the breakdown of organic mulches. Use ground cover to reduce weeds.

Landscape fabrics interfere with the breakdown of organic mulches (worms and insects can't get through them). They can also interfere with root growth. Their removal is recommended whenever possible. Planting of ground covers would help keep weeds down while lessening the need for both mulch and landscape fabrics.

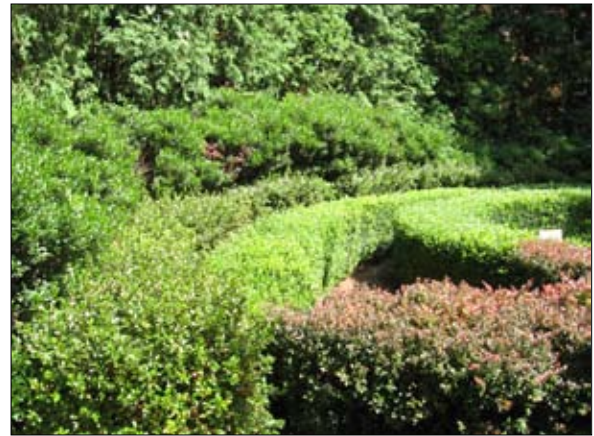
The Potter garden and fountain are looking somewhat overgrown, with plants quite crowded and the azaleas especially competing for space. Consider renovation of this garden. The winter character might be improved if the barberry portion of the hedge were removed and replaced with boxwood for a more uniform look.

Crowded conditions in Potter garden

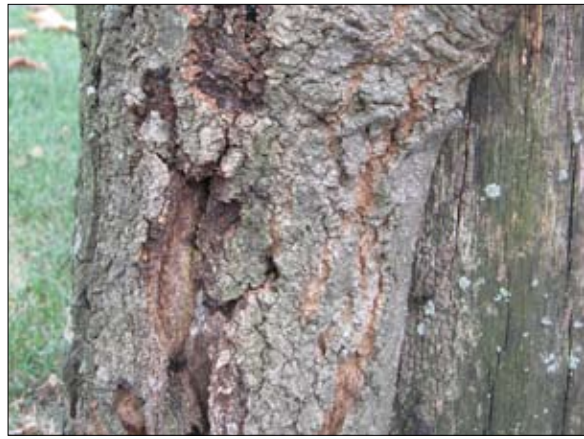
Oak has significant bark damage and rot.

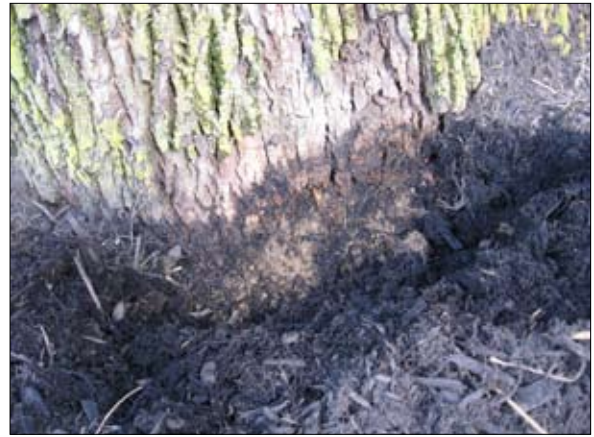
Rot! Keep mulch at least 2" away from white ash trunk.

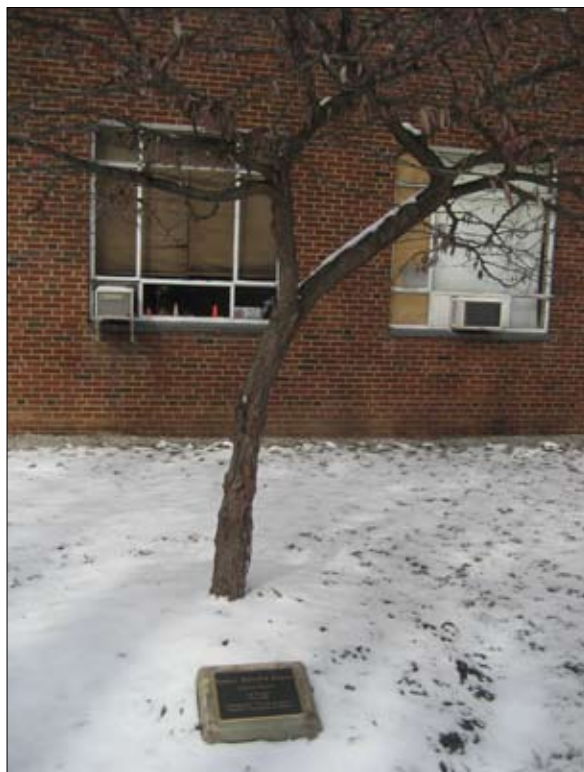
Memorial redbud dying of canker disease. Redbuds have a short lifespan of approximately 20 years. Consider replacement with a longer-lived species.

Dying redbud. Replace with a hardier species.

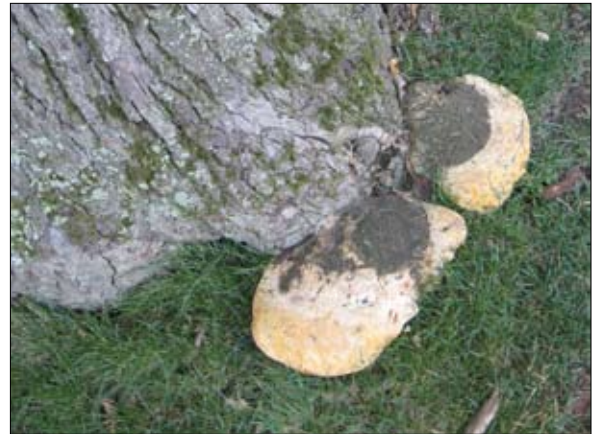
Conk (fungal) growth encourage by damage.

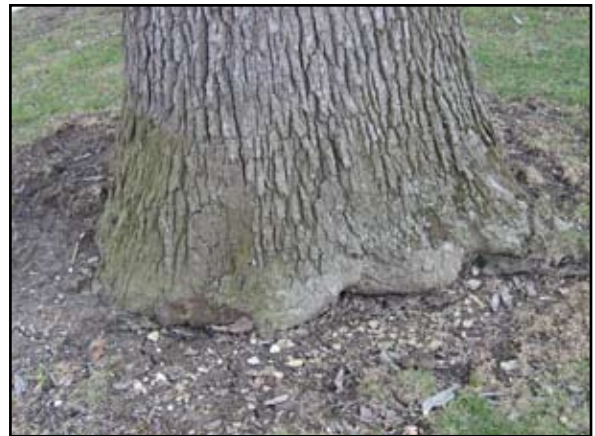
Damage to base of great tree.
