PRESERVATION PLAN

INDIANA UNIVERSITY OF PENNSYLVANIA

Indiana University of Pennsylvania
Indiana, Pennsylvania

Prepared by
**PH PITTSBURGH HISTORY &
LF LANDMARKS FOUNDATION**

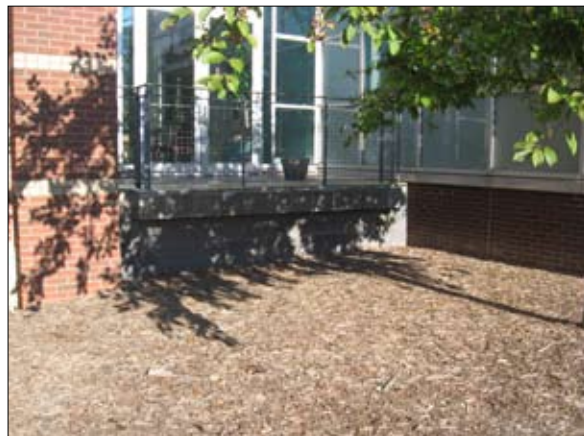
Consider eliminating vast fields of mulch.

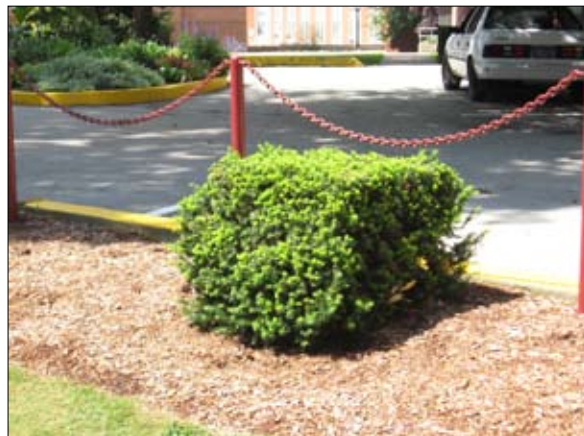
Avoid "boxes" or "gumdrops". Let yew grow naturally.

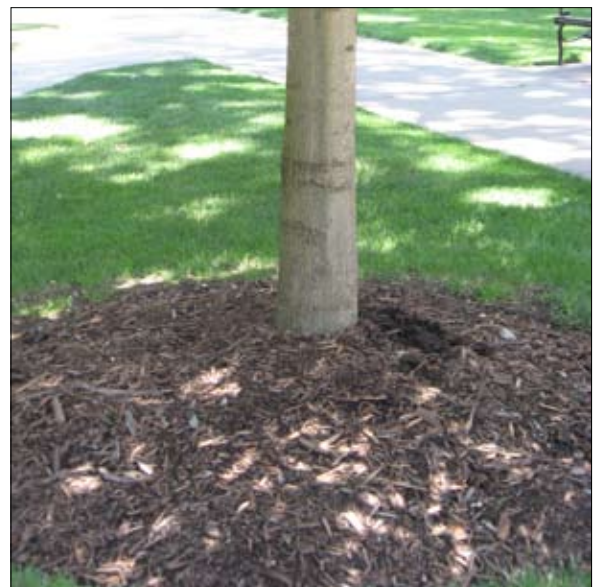
Mulch too thick. Reduce to root flare.

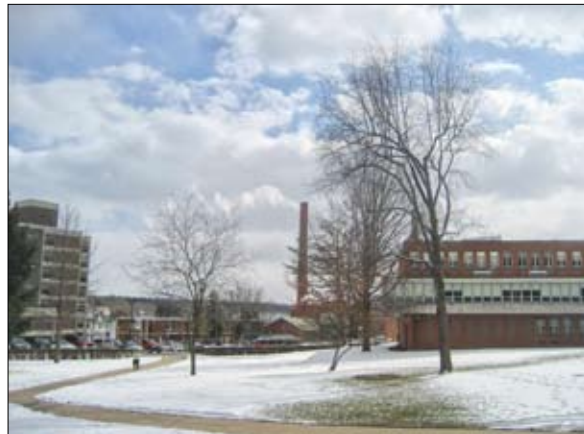
Add trees to East Lawn to eliminate empty void.

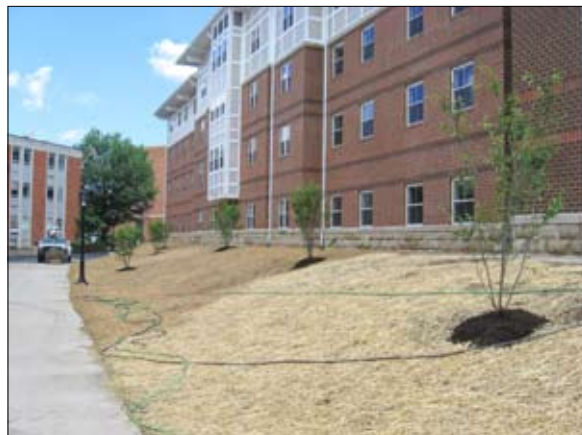
Consider moving small amelanichiers along the Northern Suites and replacing with a larger specimen.

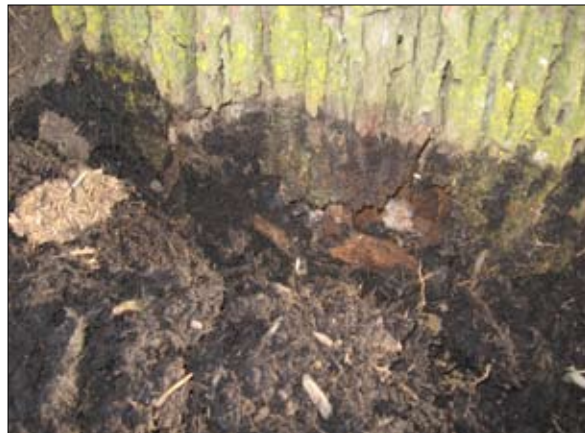
Overmulching encourages insects, disease and bark rot

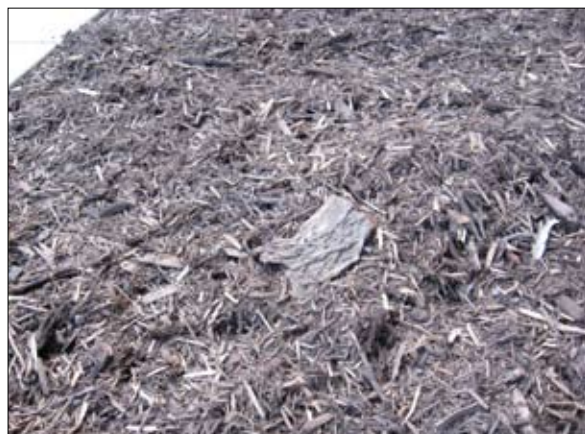
Thick mulch

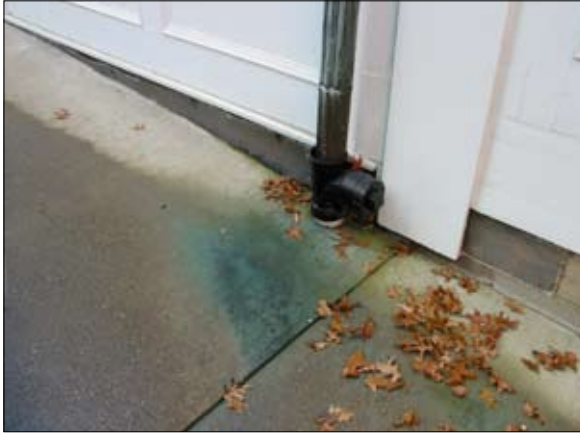
Keep moisture away from foundations, check downspouts

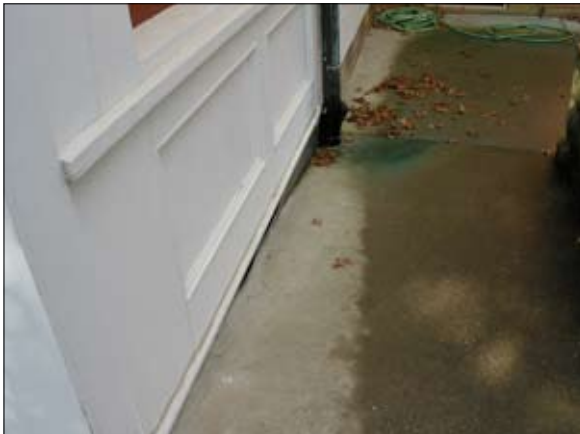
Keep moisture away from foundations, check downspouts

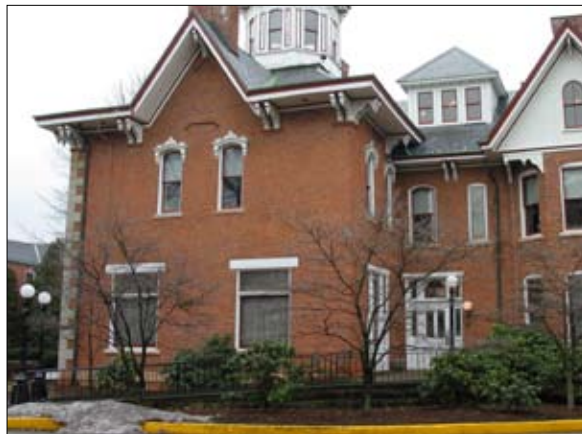
Replace dying dogwoods with disease resistant variety.

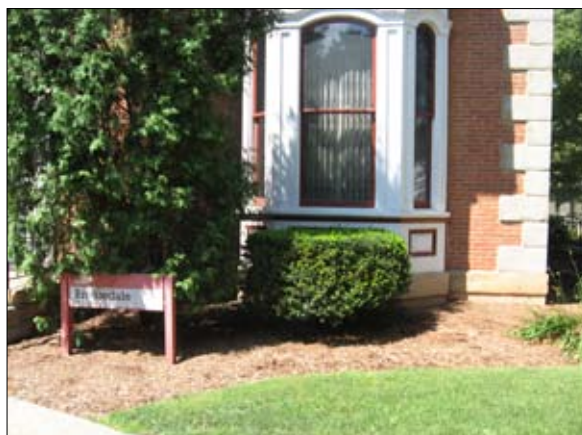
Replace yews with more-effective ground cover.

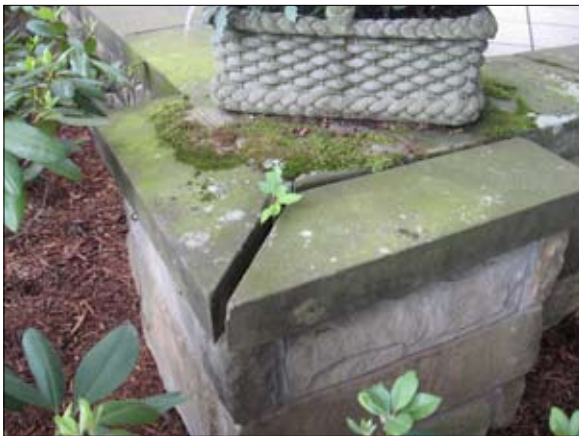
A broad porch extends from the building to the south. This porch is nicely shaded by two oak trees. The stone caps on the porch railing show loose stones and open joints and should be repaired.

Repair stone caps, matching color and texture.

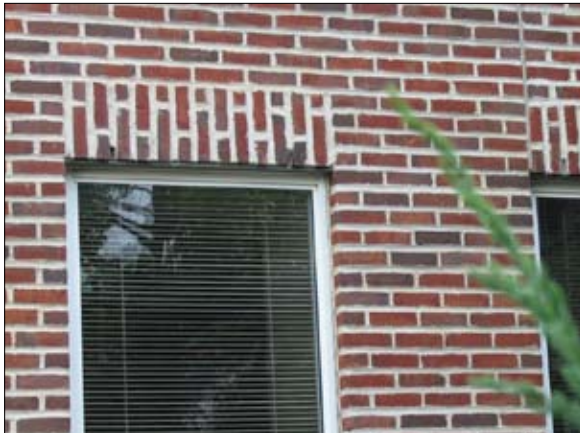
Mortar joints mismatched in size, color, and texture.

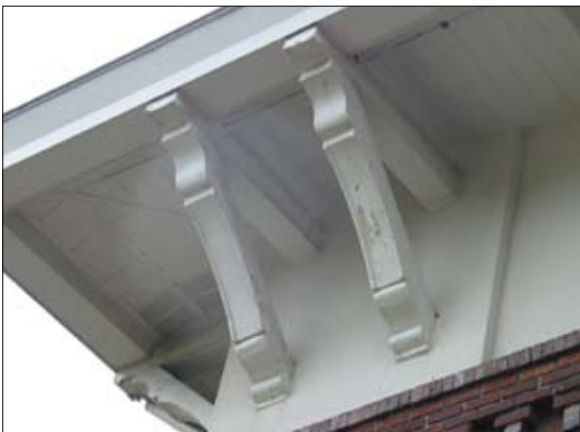
Scrape, prime and paint cornice and trim as needed

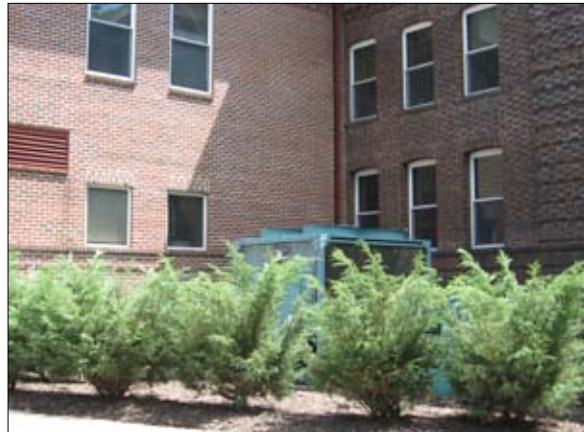
American hornbeams planted to either side of entry walk are a good choice for this area. Junipers planted as screening hedge have nice natural shape. Maintain this effect. Mechanical equipment could be painted like downspouts and vents for better integration.

Paint mechanical equipment to blend with masonry.

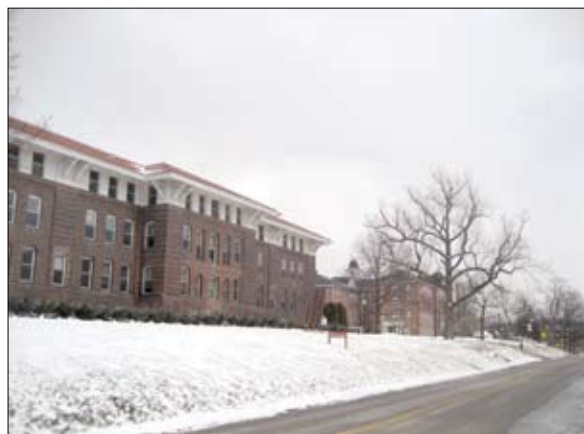
Street trees would enhance an otherwise empty area.

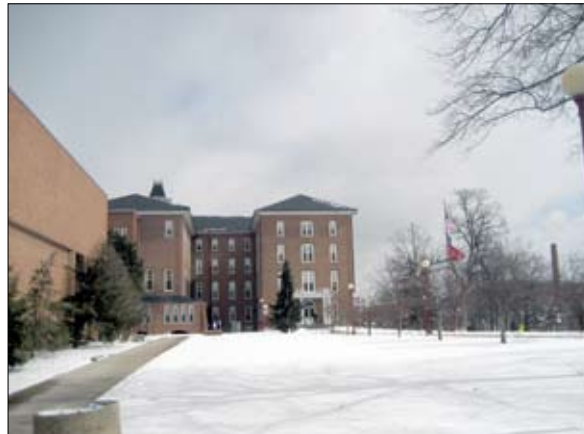
Open space is dull. Consider a planting plan.

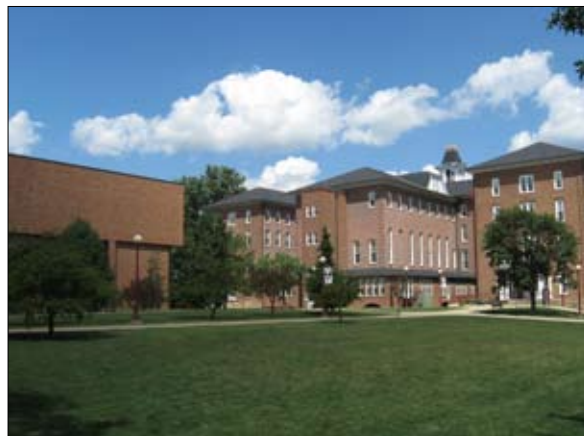
An allee of crabapples is missing trees and is undersized for the volume of space. These small trees do not make a strong enough impact. Larger trees are needed in this area.

Trees are out of scale, larger specimens suggested.

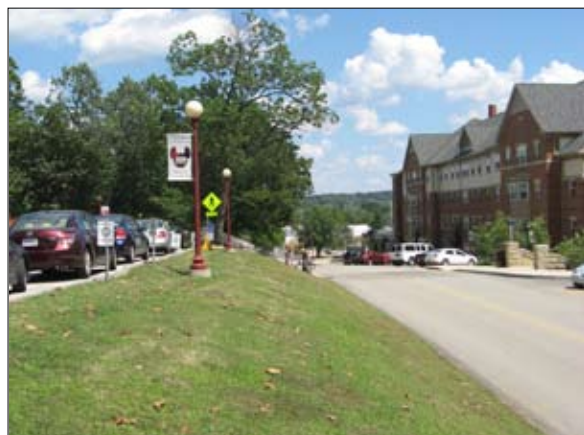
Additional trees on slope will enliven area.

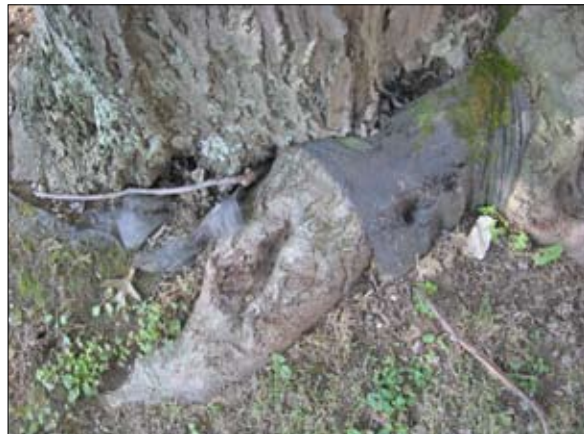
- Area under construction spring/summer 2008
- Remove landscape fabric around bases of mature trees as it appears to be contributing to abnormal root growth.
- After construction is finished mature trees should have aeration and deep root fertilization to mitigate possible compaction issues in the area.

Landscape fabric is retarding growth of trees. Remove.

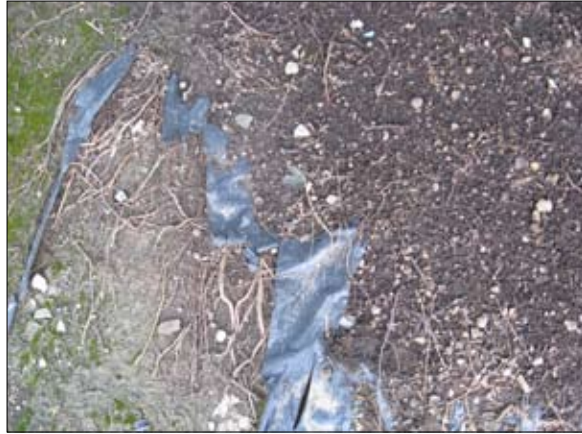
A line of oaks is planted along the walk between the Hadley Union Building and Keith Hall. This could create a strong effect long-term but the trees are not as healthy as might be hoped. The oaks have black plastic and landscape fabric at the base which is causing abnormal root growth as the roots attempt to grow above the black plastic. The ground is compacted and bare. Remove the fabrics and prune girdling roots. Ground should be aerated and trees should be fed and mulched, ideally with leaf compost.

Black plastic causes abnormal root growth. Remove.

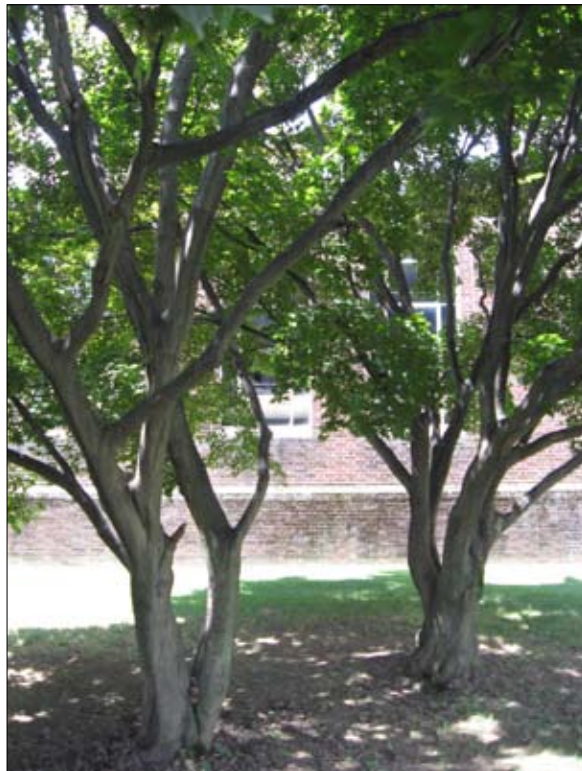
Mulch or ground cover needed for Japanese Maples.

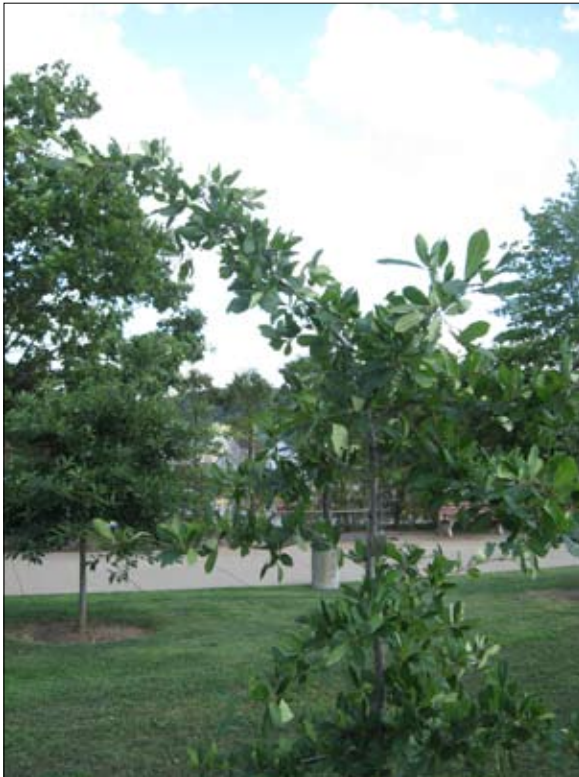
A new planting of Black tupelo (*Nyssa sylvatica*) mirrors these oaks. This grove will create a striking autumn effect. A number of these trees have curved tops and should be staked to ensure they develop straight leaders.

Curved Black tupelo

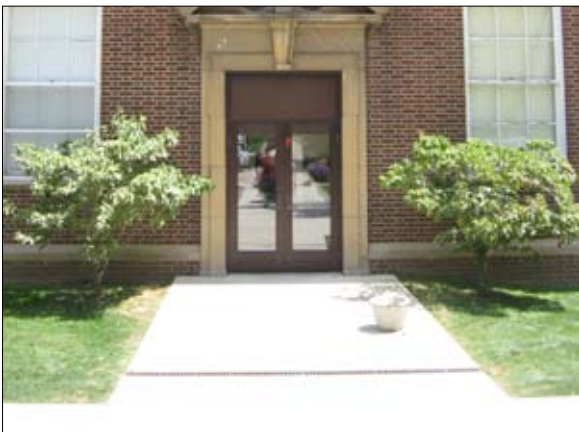
No plants along building except two dogwoods near entrance 7. Trees are stressed and need attention or replacement. Nice architectural detailing along base of foundation precludes need for foundation plants.

These dogwoods are stressed and need attention.

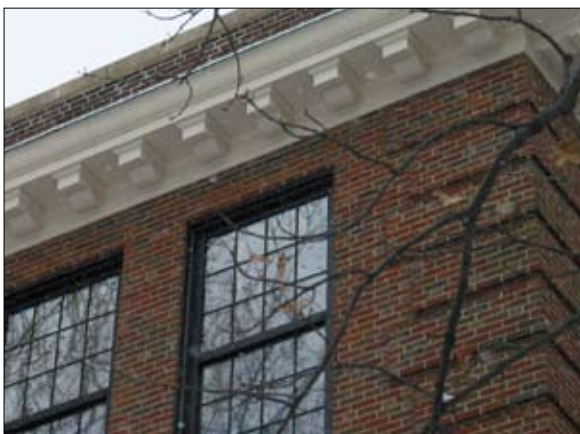
Masonry repairs should match color, texture, and size.

- When repairing masonry, match existing color, texture, and size.
- Landscape in methods that control water away from foundations.
- Landscaped retaining walls, should be closely examined to establish cause of movement; corrected repairs should be made.

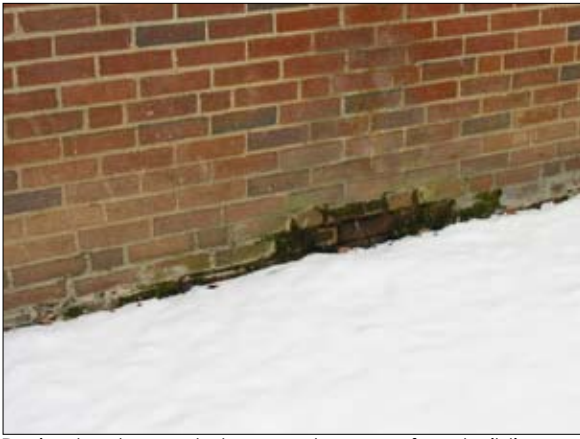
Design landscape to keep water away from buildings.

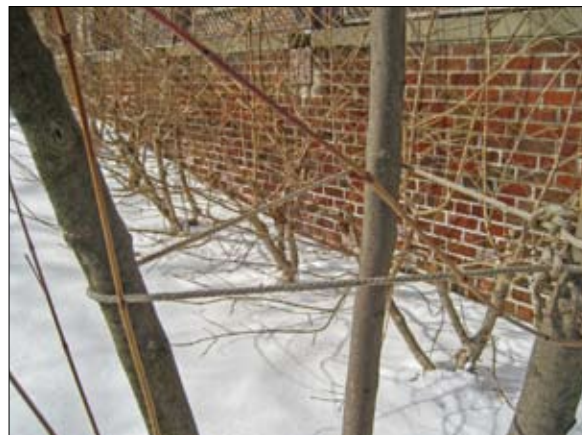
Kousa are dying. Diagnose and treat.

Kousa under the oak is dying. Diagnose and treat if possible.

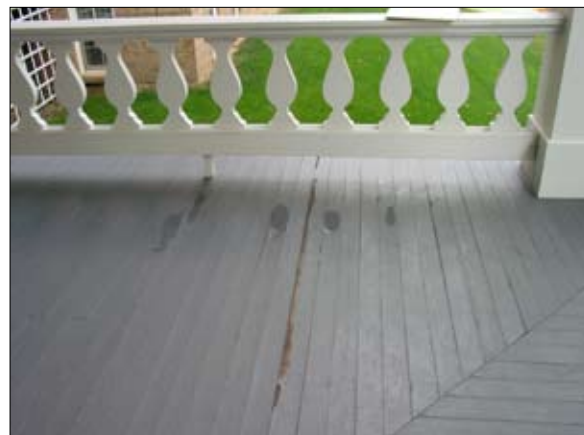
Repair wood flooring.

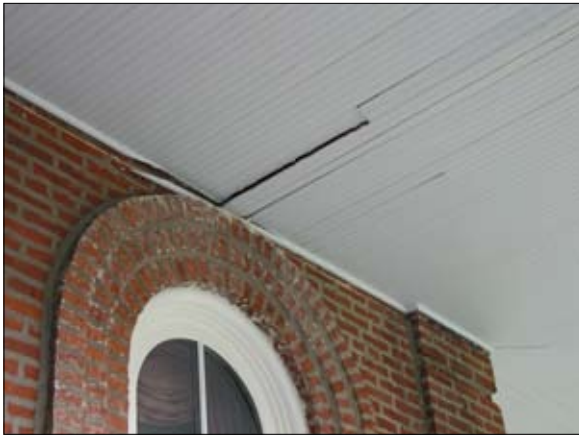
Repair wood trim.

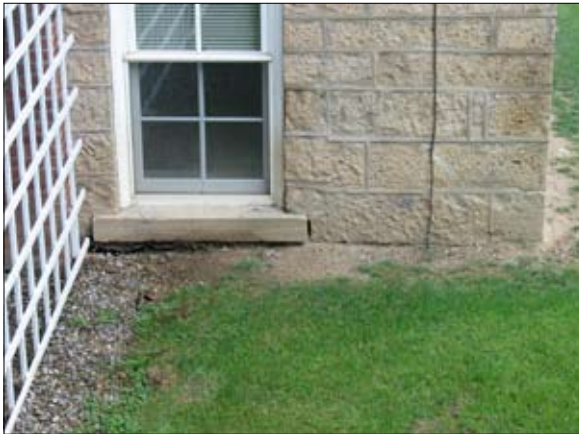
Keep dampness away from foundations.

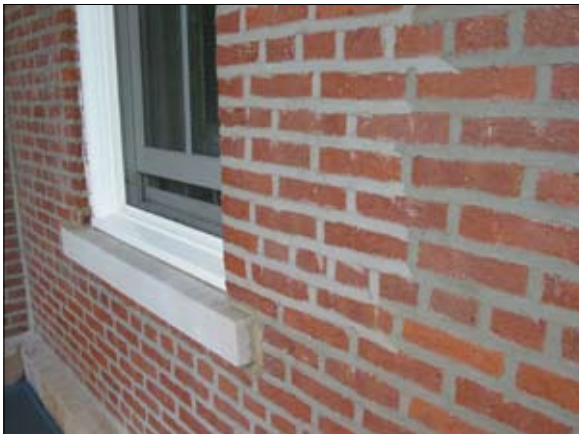
Mortar mismatch. Match color and texture.

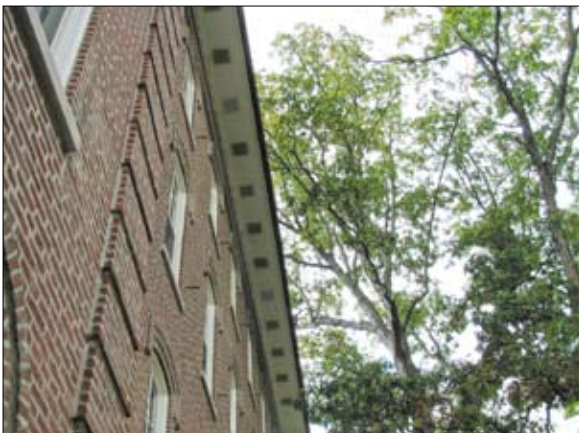
Keep trees back from roofline.

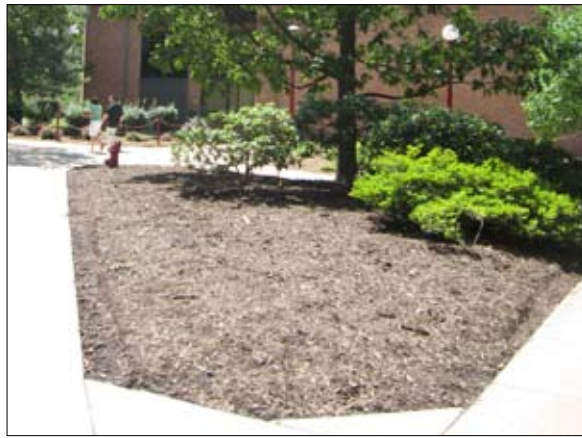
Treat azaleas for lacebug infestations.

Consider reducing height of planting island between Sutton and Stapleton library for more natural slope. Add additional shrubs to create mass. Treat azaleas for lacebug infestation. Consider adding ground cover to beds. Add tree to open corner of more southern bed. Remove lower branches of oak. Check mulch thickness and pull mulch away from trunks of all plants.

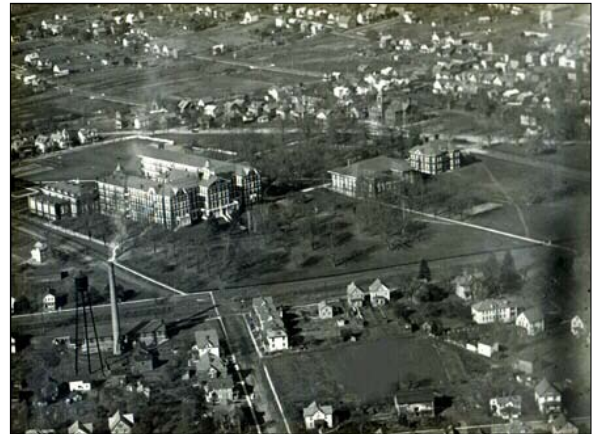
Historic photo shows heavier tree cover.

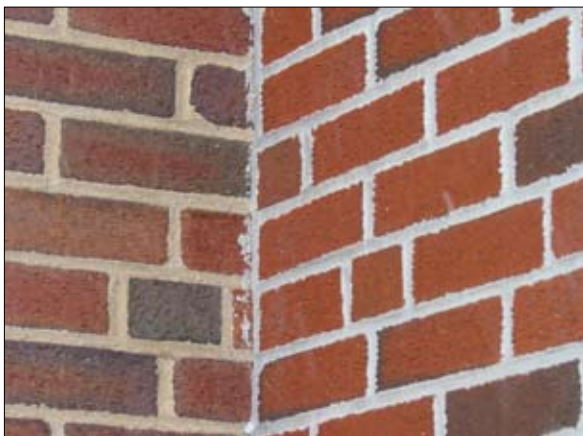
Improper repair. Mortar color and texture mismatch.

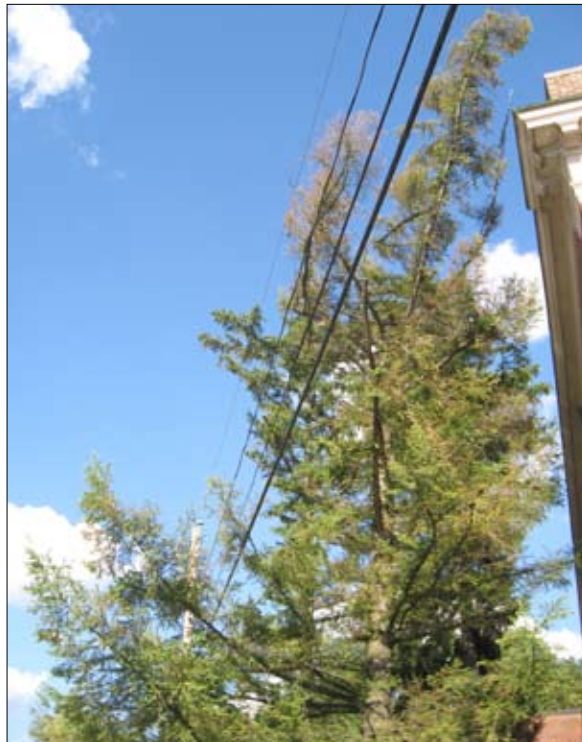
Two Japanese larch trees near Oakland Ave. have been pruned due to wires which have disfigured their shape. Consider planting new specimen larch trees in another area of campus.

Larch disfigured by utility. Consider replacing.

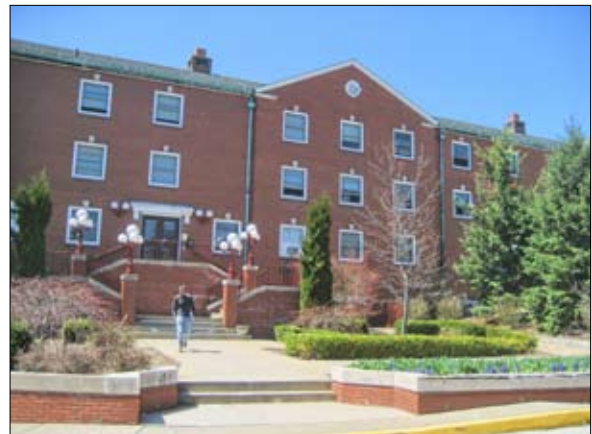
There is a lacebug infestation here. Treat as needed.

salvageable plants to more conducive location and feed with Holly Tone or other suitable plant food. Treat for lacebug infestation.

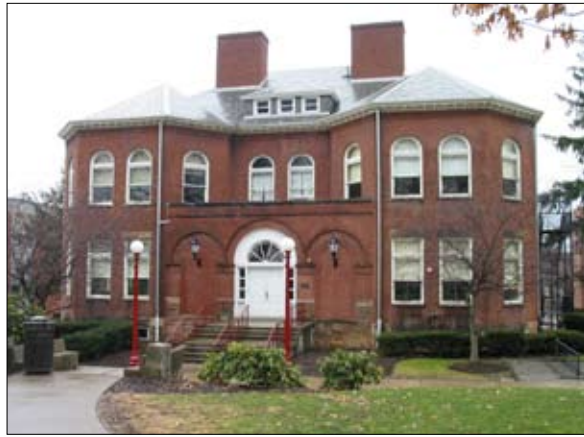
Simple evergreens work better.

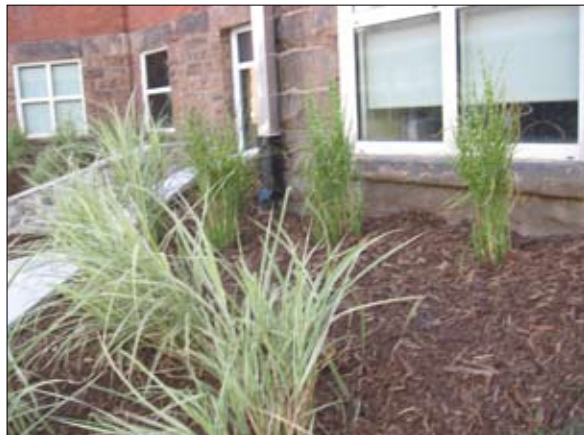
Zebra grass is planted too close to building.

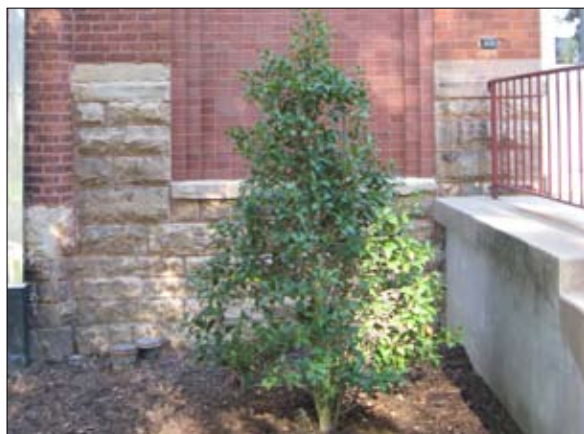
Wilson holly requires careful pruning over the years.
